# SERVICE INFORMATION

Two-cylinder motorcycles  
Group: Engine

München, 25-9-1964  
Nr. 4/64 (214) en

Re: Strange engine and transmission noises being developed in some cases on the two-cylinder models

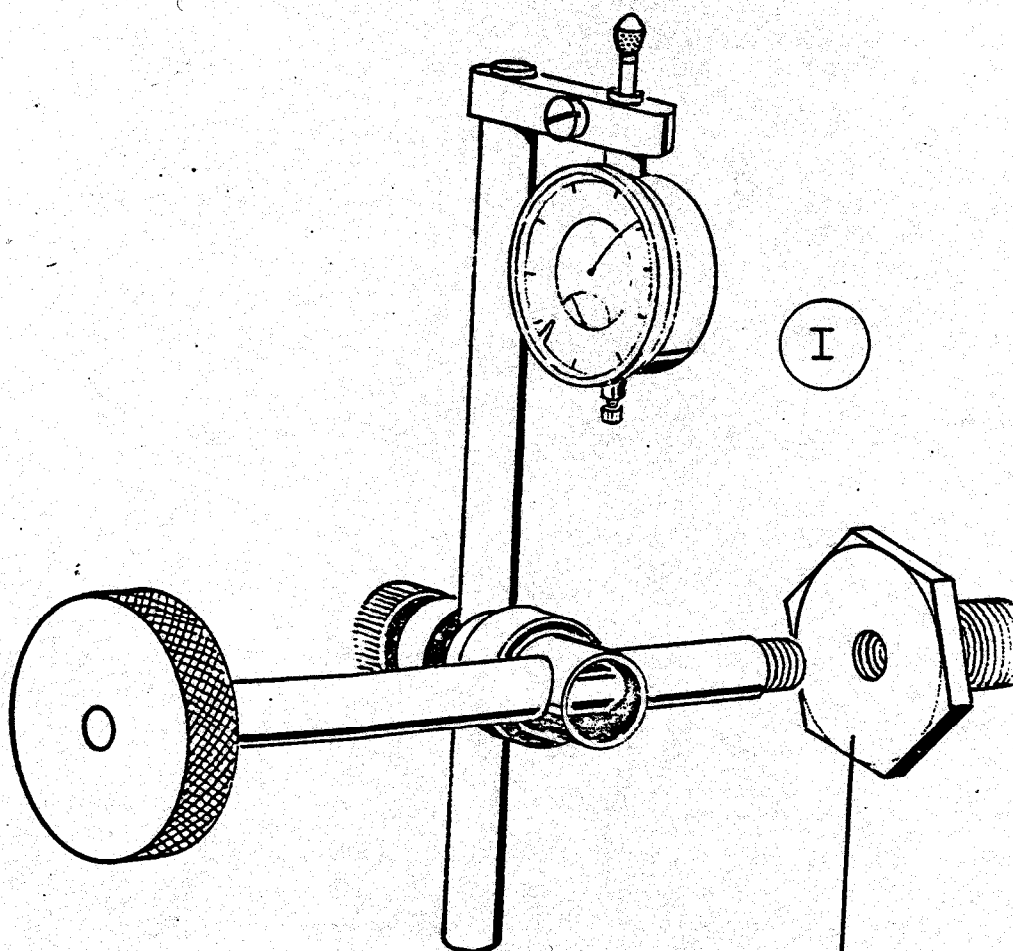
## Messvorrichtung (Schema)

The strange, partly creaking or crushing noises being developed from a running engine, which already disappear when slightly pulling the clutch, as well as ball bearings getting defective prematurely on the transmission primary shaft at front are due to an offset rotation axis of crankshaft to primary shaft of transmission.

If then, by checking round the large centering bore for the transmission, on the flywheel bellhousing (228 mm  $\varnothing$ ) an offset larger than 0.05 mm (equalling a total runout of 0.1 mm) is measured, dismantle the engine completely.

1. Before totally dismantling the engine, remove clutch and flywheel retaining screw. Install a dial gauge with support and rods (see sketch) or our universal measuring device 5104 (with supplementary support for dial gauge) on rear journal end of crankshaft. As support for the measuring device serves a flywheel retaining screw provided with a corresponding thread.
